Orphan Breakwaters - what protection is given when they collapse?

Orphan Breakwaters – what protection is given when they collapse?

Abstract

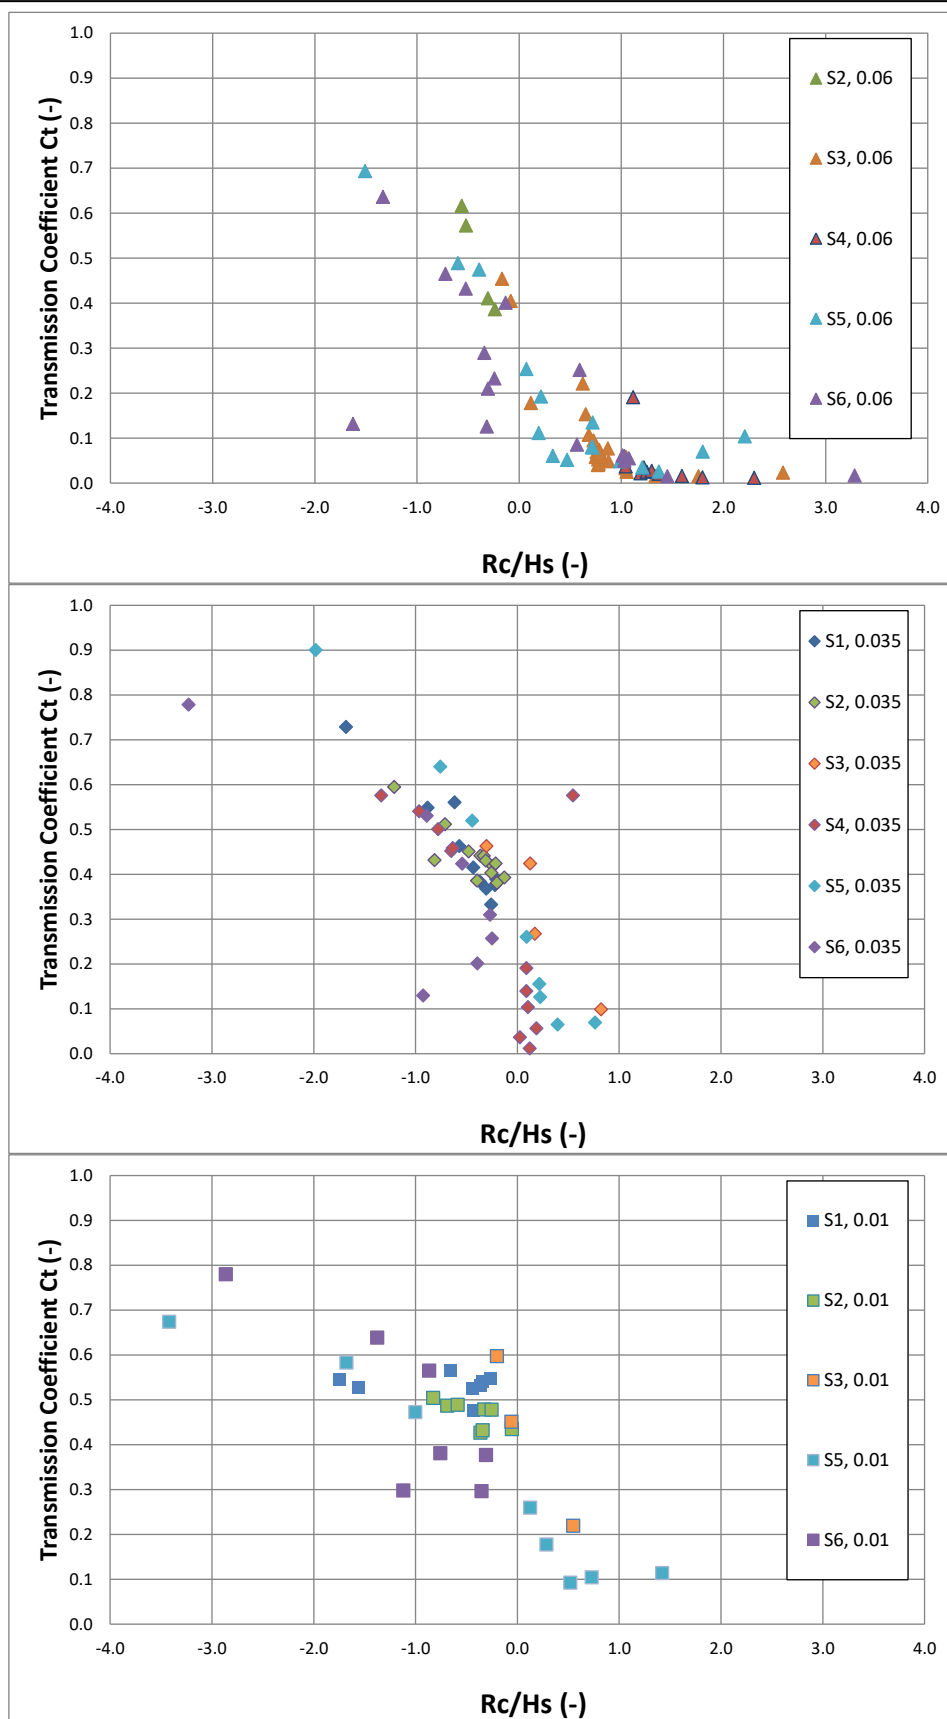
Figure 27: Wave transmission, C_t vs R_c/H_{si} : $s = 0.06$; $s = 0.035$; $s = 0.01$

The form of presentation of wave transmission measurements in section 6 links C_r and C_t to the damage process, but this form is not easily used to predict transmission. Values of transmission coefficient C_t have been plotted against the simplest dimensionless freeboard, R_o/H_{si} , in Figure 28, using mound crest levels from the profile measurements and the test water level to calculate R_o . Results for each of the test steepnesses have been plotted separately in Figure 27. An attempt was made to explore whether an alternative approach by Powell & Allsop reduces scatter by including wave steepness where C_t is plotted against $R^* = (R_o/H_{si})/(\sqrt{s(2\pi)})$. The improvement was slight and judged not worth the increase of complexity in the plotting parameter.

As presented in Figure 27, the results show that there were very few instances when the crest of the damaged mound fell below $R_o/H_s \sim -2$, or where wave transmission exceeded $C_t \sim 0.6$. The few instances of higher C_t arose from inherently smaller wave conditions. At first pass therefore, these results suggest that these two limits might safely be used in any initial assessment.

The results in Figure 27 do not, however, allow easy prediction of C_t . The study results have therefore been combined in a single overall graph in Figure 28, to which has been added the prediction line given in the Rock Manual.

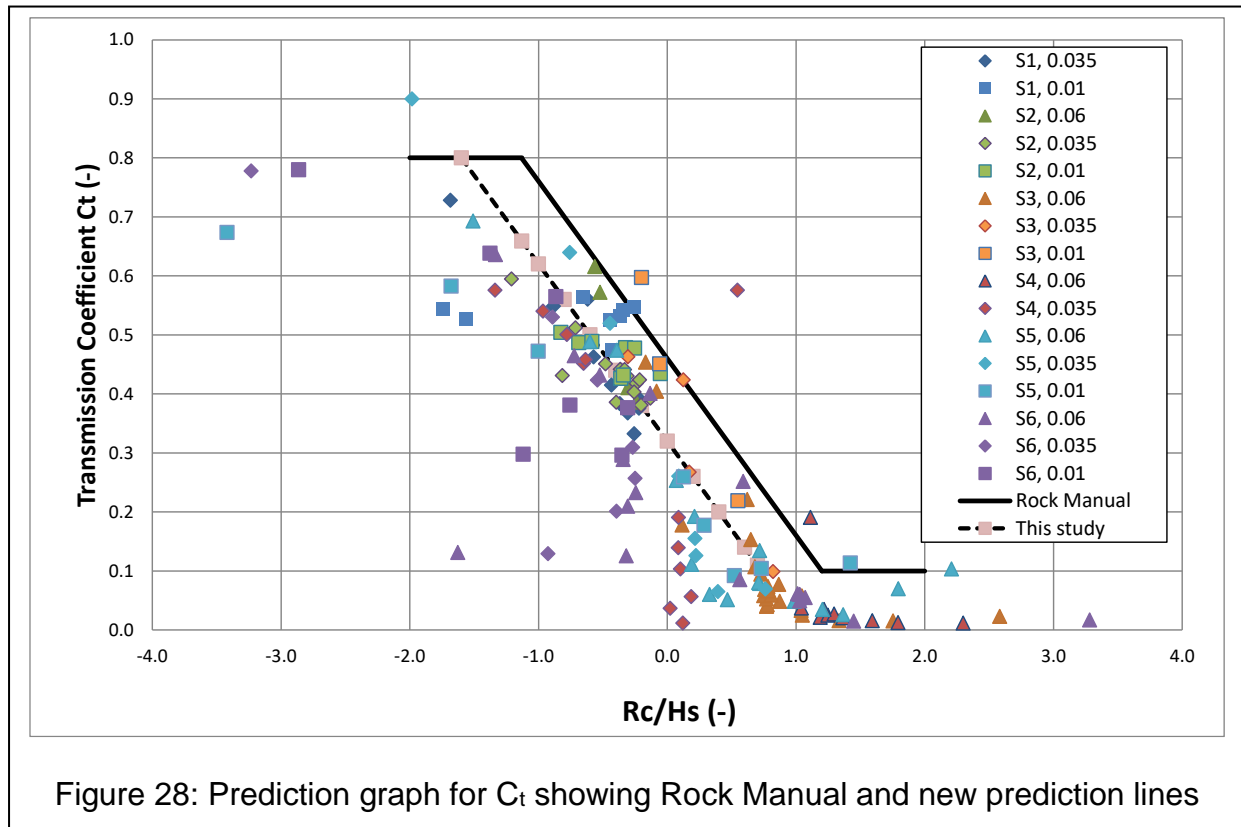
$$C_t = 0.8 \quad \text{for } -4 < R_c/H_s < -1.6$$

$$C_t = 0.32 - 0.3 R_c/H_s \quad \text{for } -1.6 < R_c/H_s < -0.7$$

$$C_t = 0.1 \quad \text{for } 0.7 < R_c/H_s < 3.0$$
